COLORADO CULTURAL RESOURCE SURVEY

Architectural Inventory Form

1. Resource number: **5SM.1814**
 2. Temporary resource number: **N/A**
 3. County: **San Miguel**
 4. City: **Telluride**
 5. Historic Building Name: **Leino House**
 6. Current Building Name: **Cook House**
 7. Building Address: **625 E. Colorado Avenue**
 8. Owner Name and Address: **Charles R. Cook
2900 Wyandot Street, Unit 103
Denver, CO 80211**

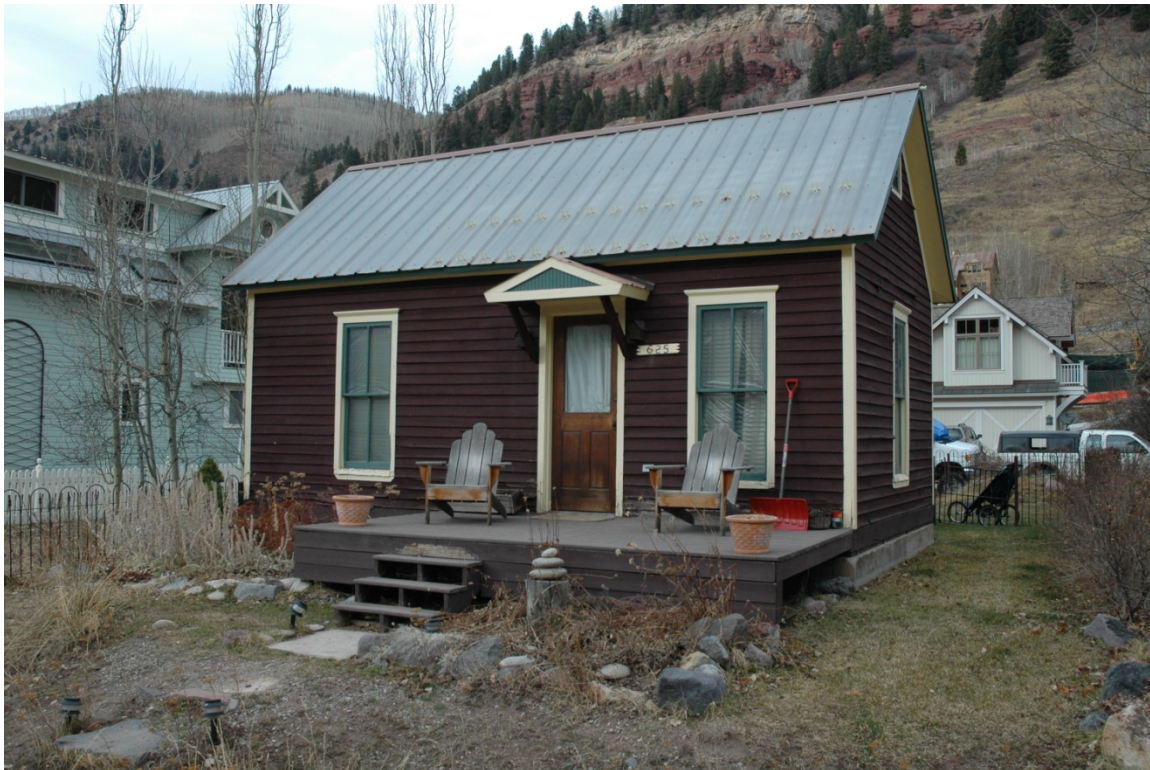
21. General architectural description:
This modest dwelling consists of a main side-gabled section to the south (front), and an intersecting gable with a shed-roofed extension to the north (rear). The main side-gabled section measures 14½' N-S (deep) by 24½' E-W (across); the intersecting rear gable and its shed-roofed extension measures 12' N-S by 18½' E-W. The building rests on an unpainted poured concrete foundation, while its exterior walls are clad with stained or painted brown horizontal wood siding with painted cream white 1" by 4' corner boards. The roof is covered with metal roofing material, and the eaves are boxed with painted green and cream white wood trim. A red brick chimney is located on the ridge. The house's asymmetrical facade faces E. Colorado Avenue on the south elevation. A stained brown wood-paneled door, with one upper sash light, enters the east half of the facade from an open wood porch. A gable hood, with knee brace supports, is over the entry door. A stained brown wood-paneled door enters the north elevation from a 4-step wooden stoop. Another wood-paneled door enters the east end of the main gabled section's north elevation. Small 6-light windows penetrate the upper gable ends on the east and west elevations. Other windows are primarily 2/2 double-hung sash with painted green wood frames and painted cream white wood surrounds.

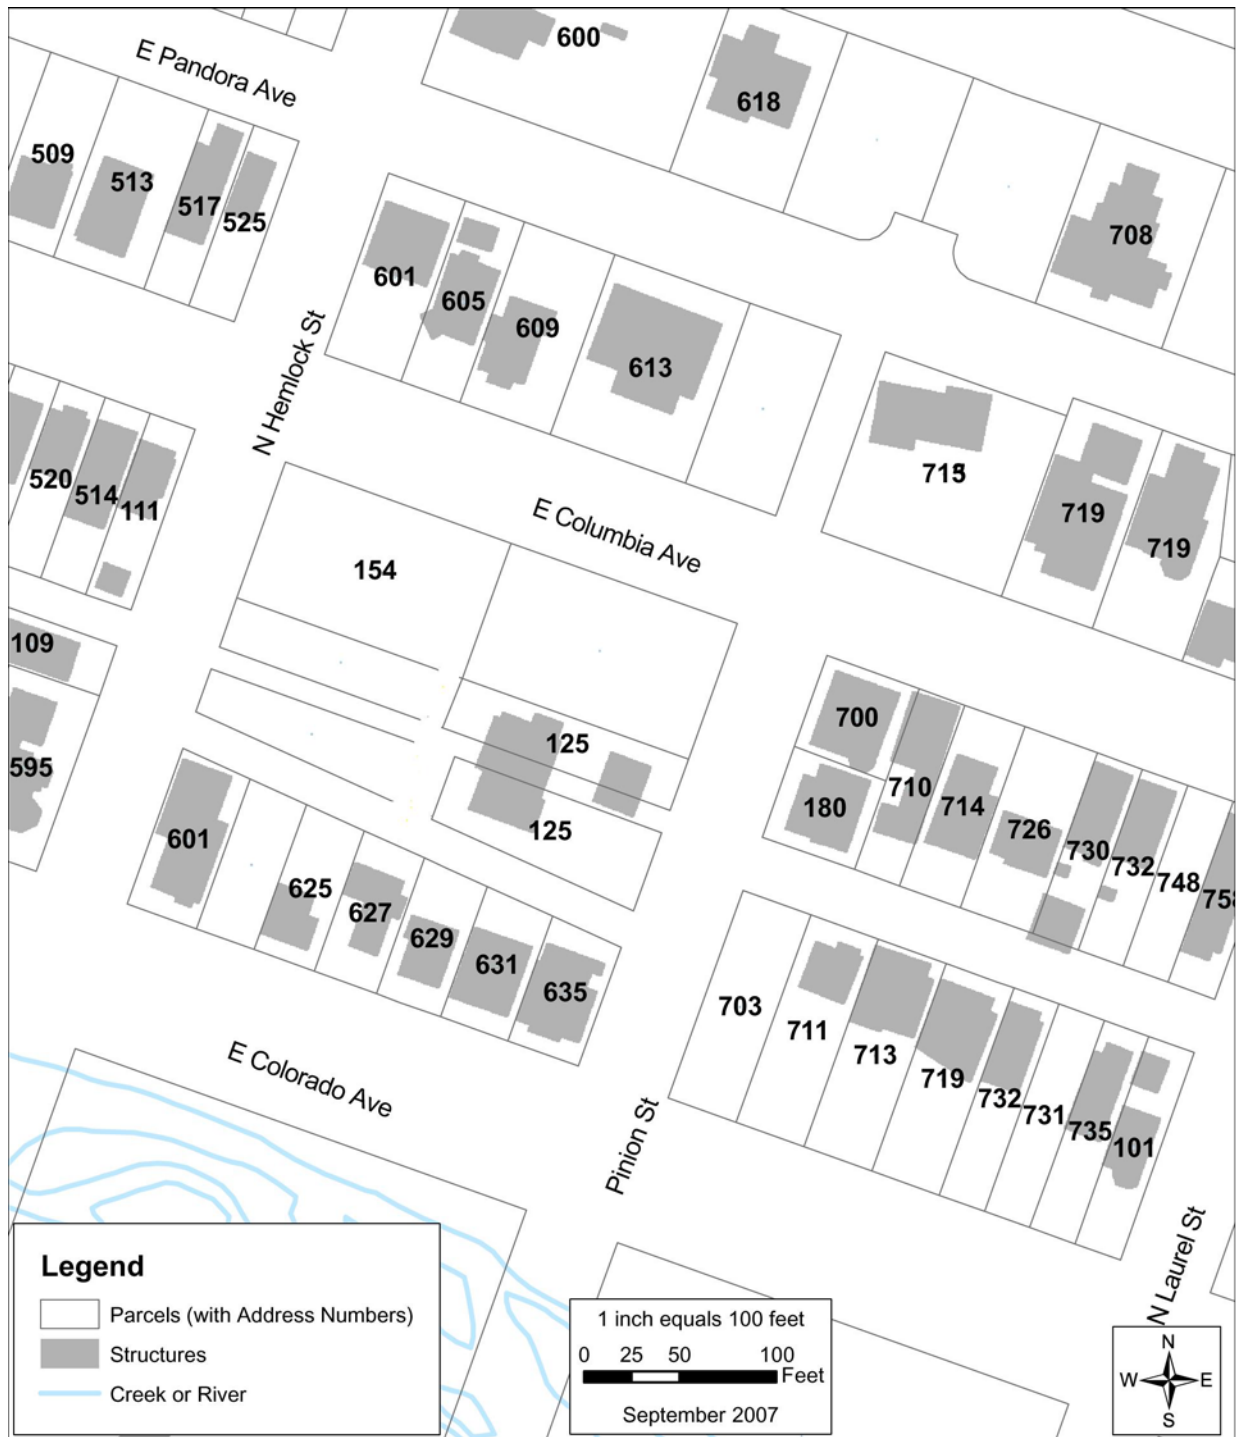
Sketch Map

This well-maintained property is located on the north side of Colorado Avenue in the block east of Hemlock Street, a few blocks east of downtown Telluride. A historic black wrought iron fence encloses a planted grass lawn which is nicely landscaped with native plants, flowers, and aspen trees.
